EVALUATION OF MEMBRANE-TYPE MATERIALS FOR STREAMBANK EROSION PROTECTION

Dewey W. White, Jr.

Geotechnical Laboratory
U. S. Army Engineer Waterways Experiment Station
P. O. Box 631, Vicksburg, Miss. 39180

August 1981

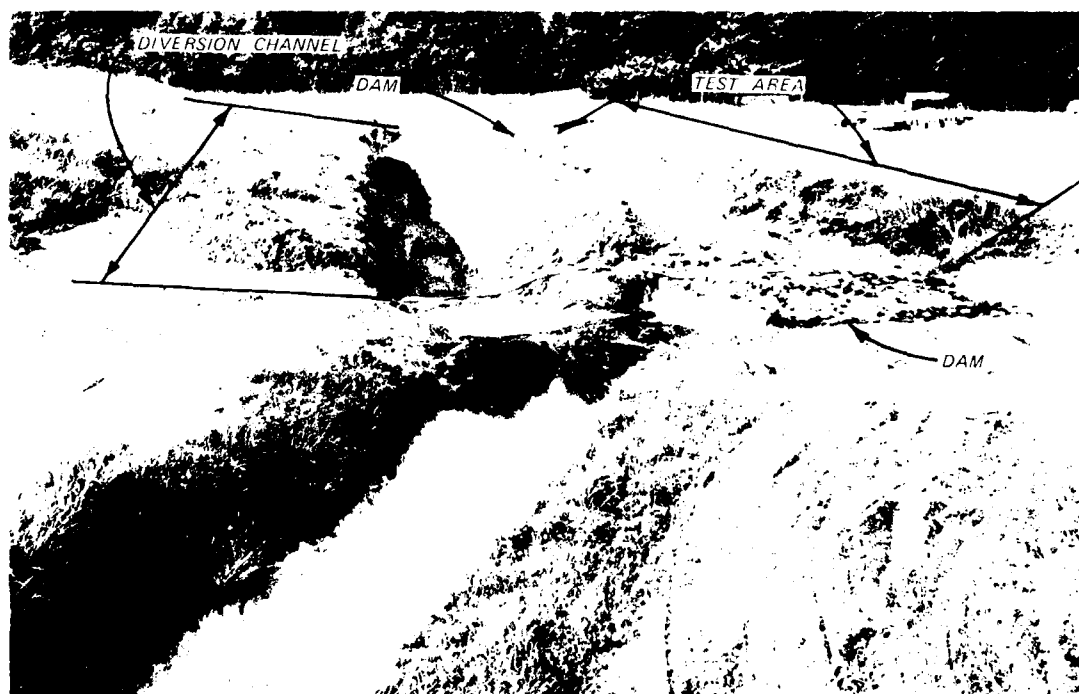
15. The bank just upstream of the test area curved (Photo 5) to the extent that it permitted the construction of a diversion channel that allowed the water to be pumped from the area where the test materials were to be installed (Photo 8). Dams were placed at each end of the test area; however, after these dams were overtopped when heavy rains occurred (Photo 9), the water had to be pumped out so the bank would dry before work could continue on the test area. The placement and the installation of materials were made along the creek bank just below the normal low-water level at the toe and continued up the bank slope to a location approximately 2 ft above the top bank. The existing in-place soil in the test area was identified and classified as a silt (ML) (Plate 5).

Photo 8. View (looking downstream) of diversion channel, dams and test area on Durden Creek

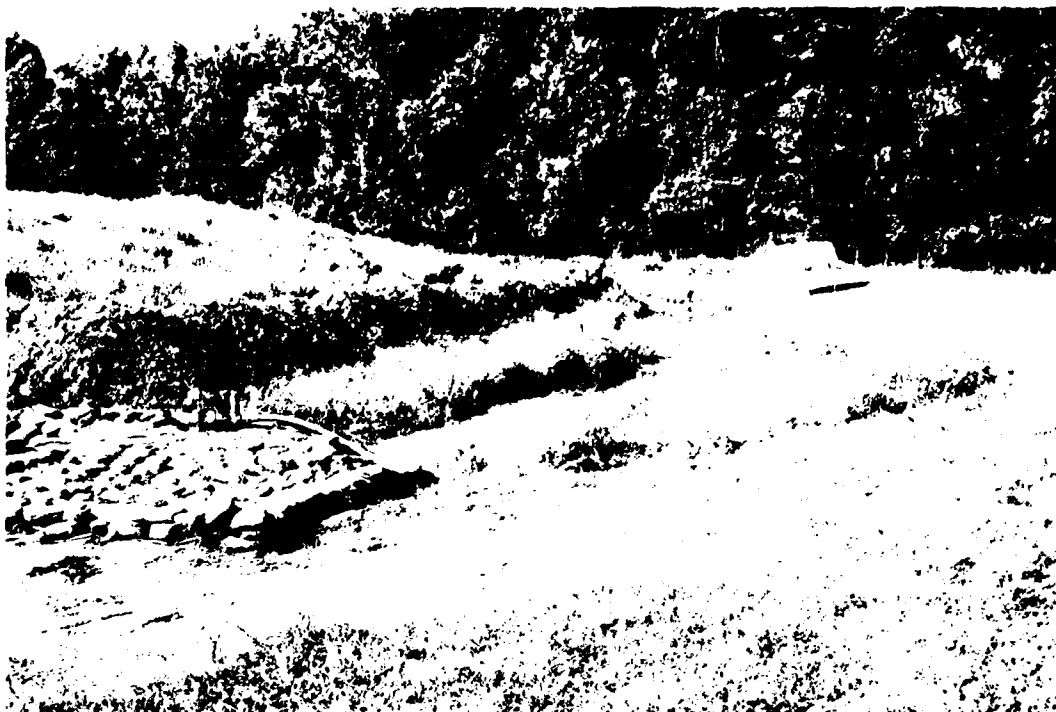
Photo 9. View (looking downstream) of test area after a heavy rain with water between the dams

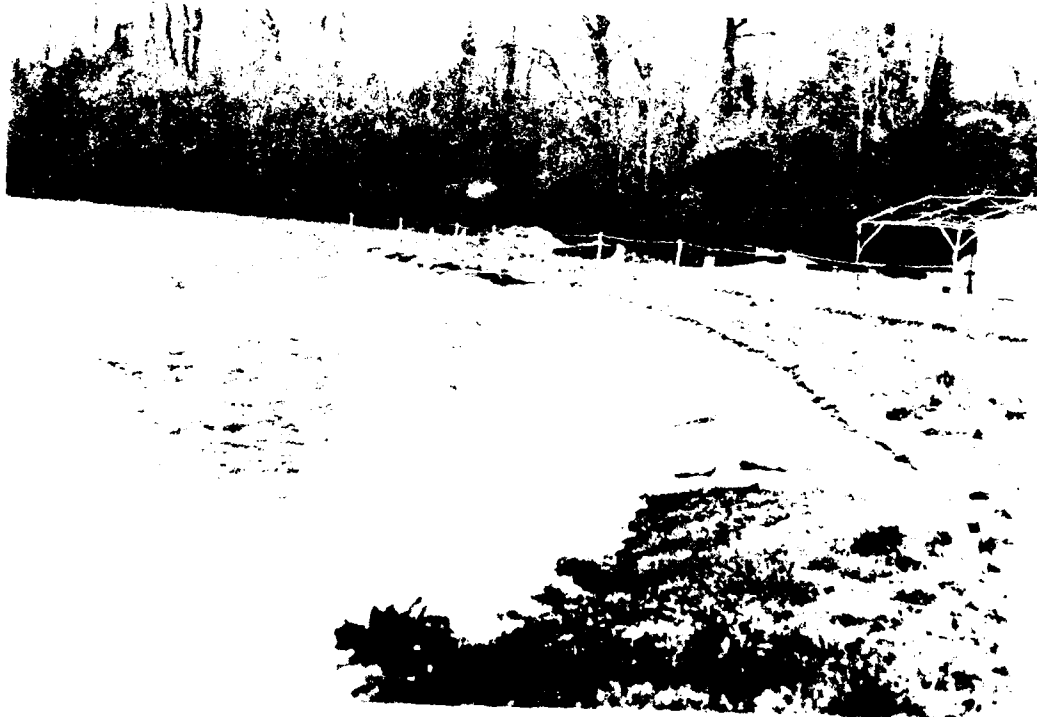
Photo 34. View (looking downstream) of test area during high water.

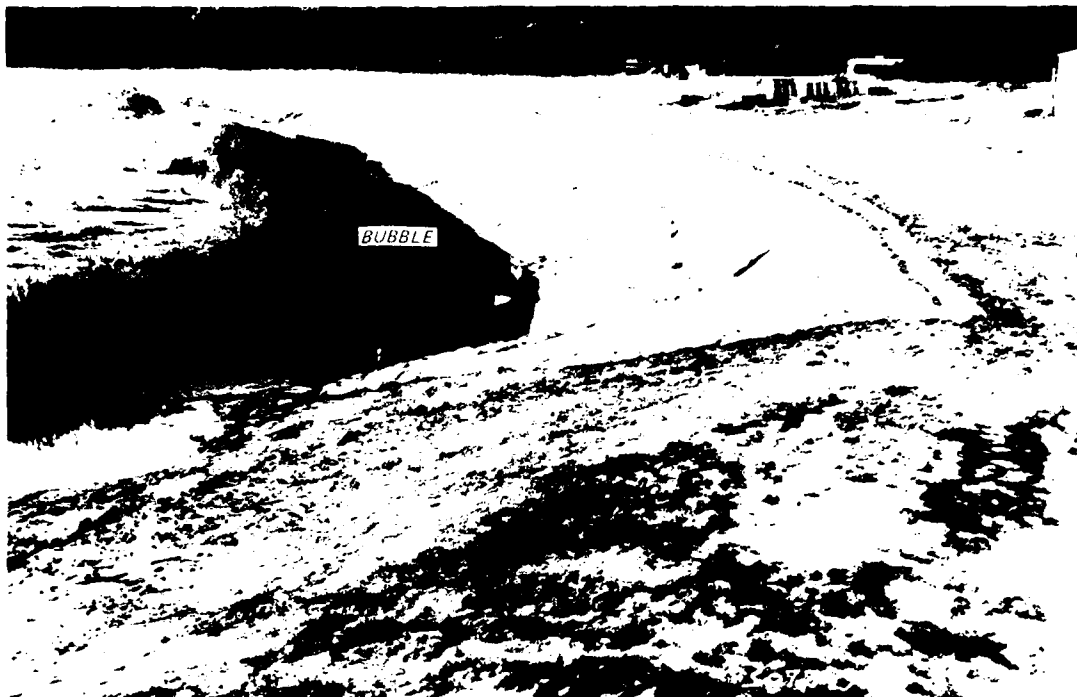
Photo 35. View (looking downstream) of test area after water had been on materials

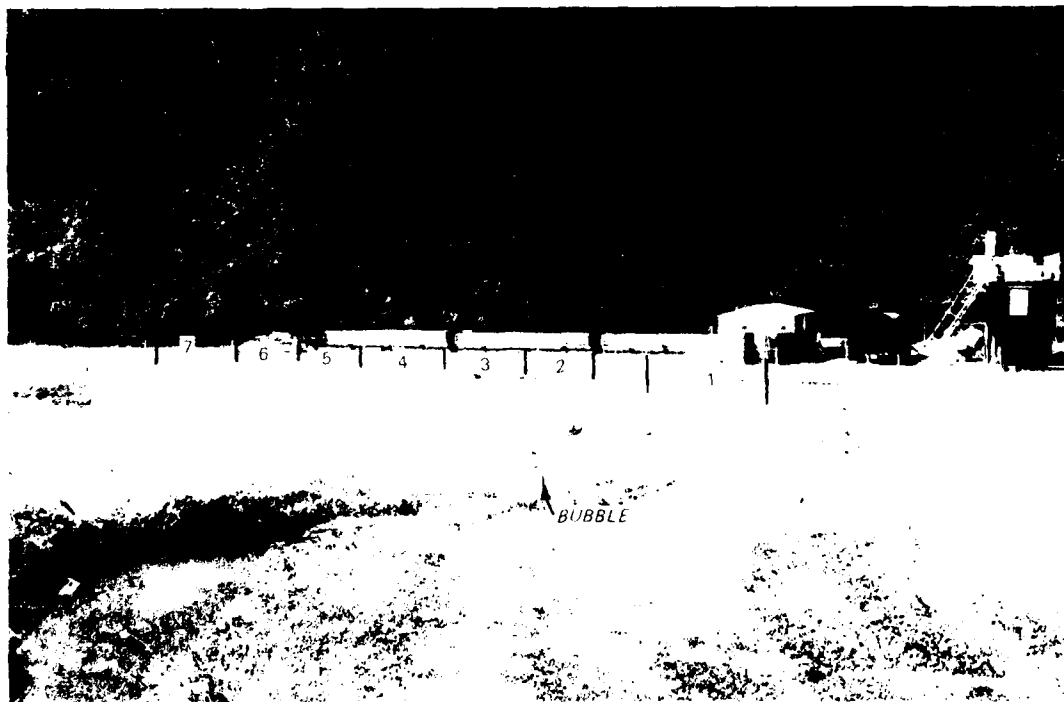
Photo 36. View (looking downstream) of test area near the end of the monitoring period

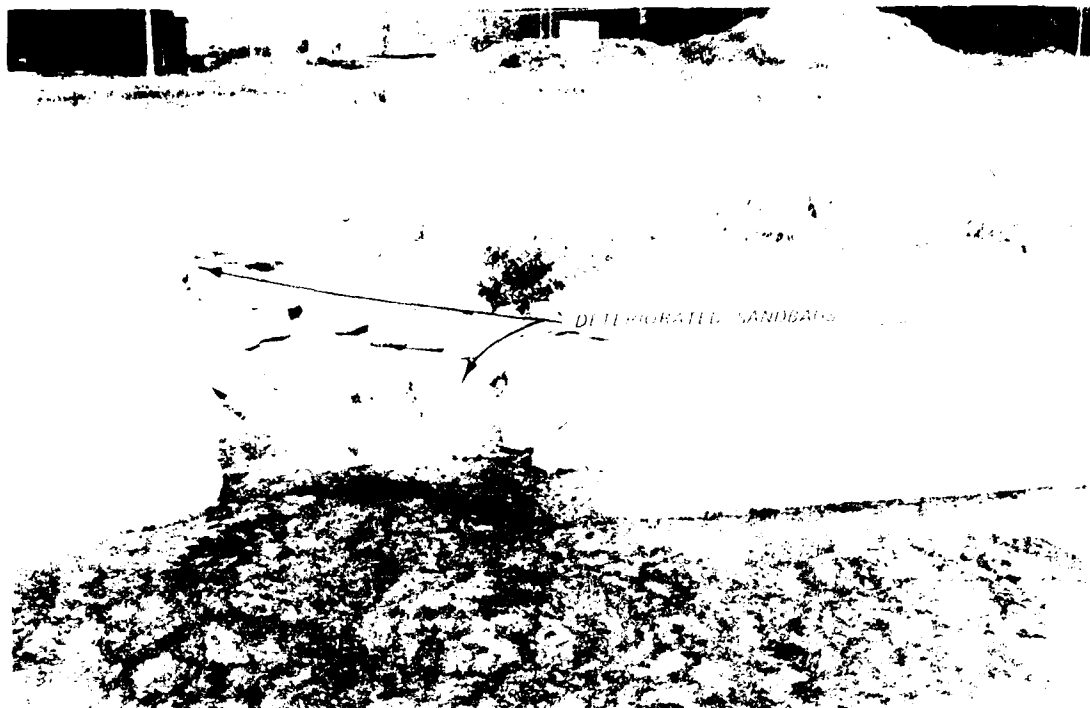
Photo 37. Typical view of deteriorated sandbags

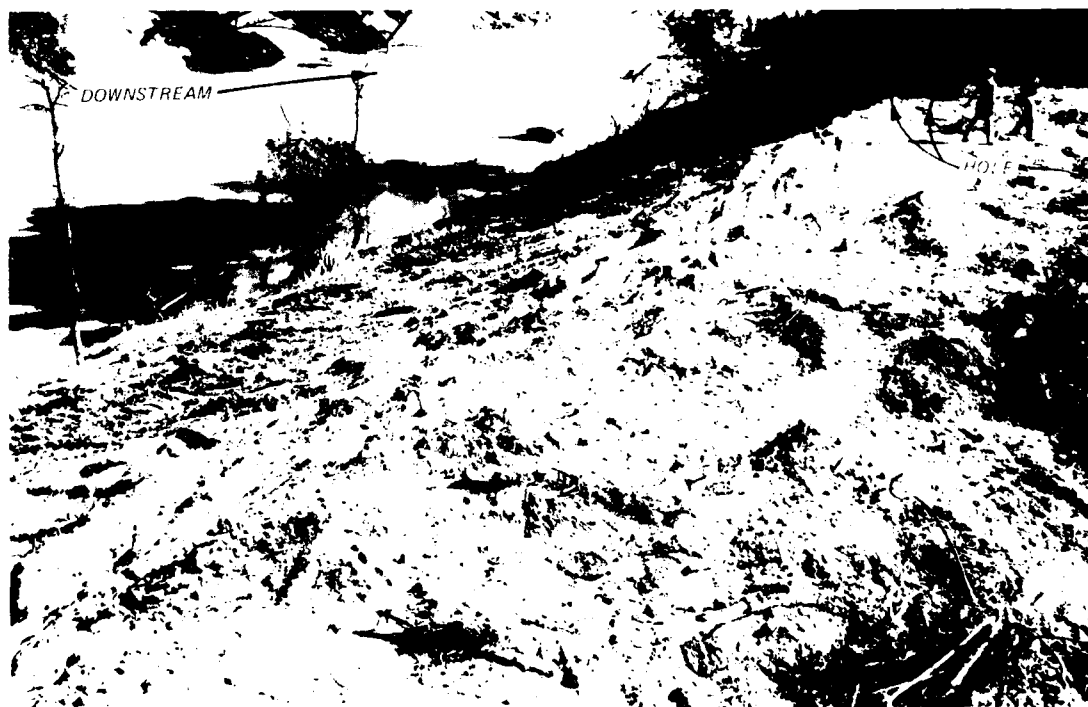
Photo 40. View of bank area with vegetation removed (note hole in bank). This area of bank selected for stepped MESL item (Item 8)

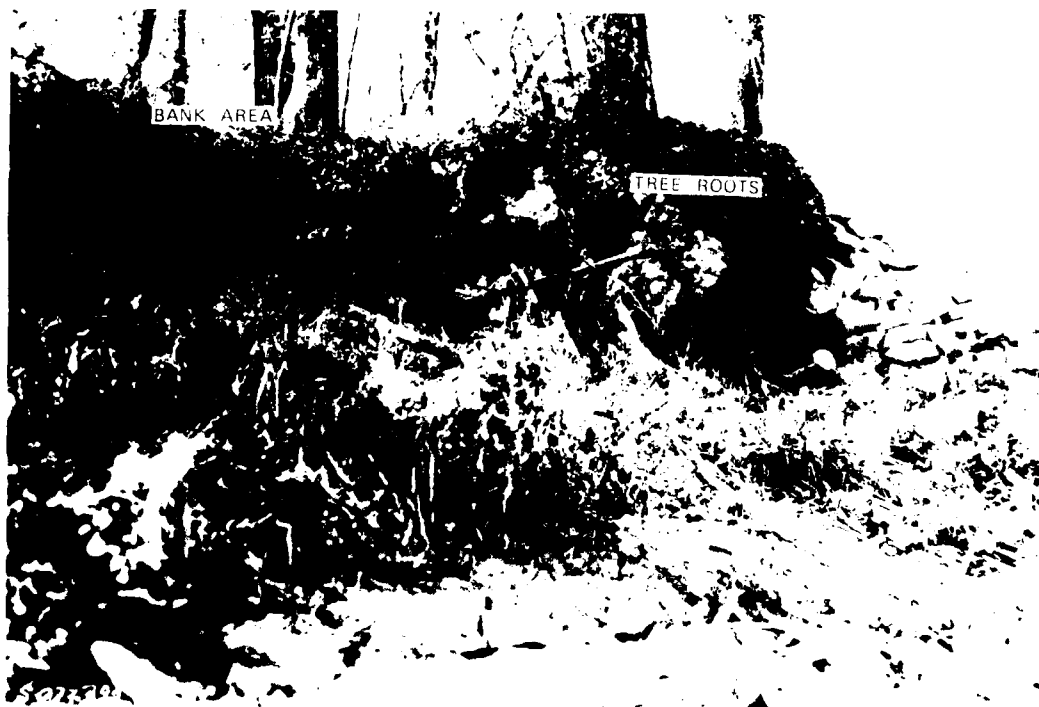
Photo 53. Area just below test Item 8 (note soil around tree roots and bank area had eroded prior to installation of test materials)

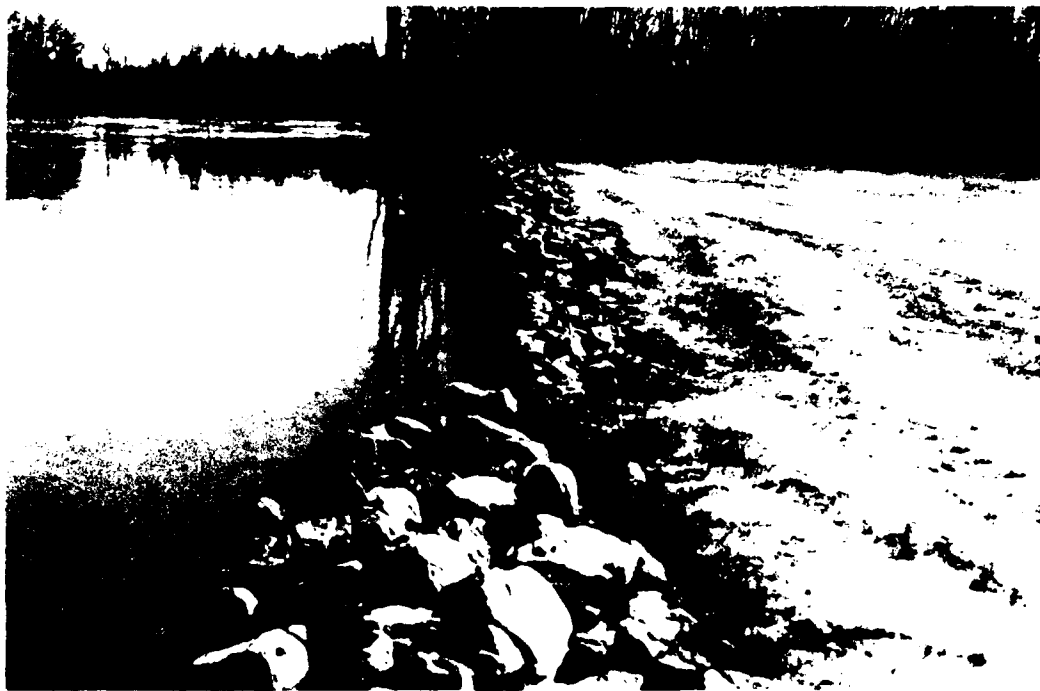
34. In mid-November 1979 (Photo 64) the river began a slow rise with slight fluctuations until the latter part of November, at which time it rose to the top bank during the first week in December (Photo 65). After the peak stage was reached near the top bank, the water level fell slowly until it reached a level between the half bank and the toe of the materials. It fluctuated around this level until 10 January 1980. Large deposits of silt were left on the test materials each time the water level of the river dropped slowly (Photo 66). From this time until the latter part of February, the water level was such that at least 50 percent or more of the test bank was covered with water because of heavy local and upstream rains. During the last week of February 1980, the water level dropped slowly for several days, and then there was a sudden drop of 10.7 ft in 48 hr (Table 3). The water level at this time was below the toe of the materials. Some shifting and sluffing of the bank at the toe of the materials (Photo 67) occurred as well as along the riverbank in areas not associated with the test area (Photos 68 and 69). There was no damage observed to the materials on the test items although the riprap at the toe anchor ditches had shifted.

Photo 65. View looking downriver at water at top bank and covering test area

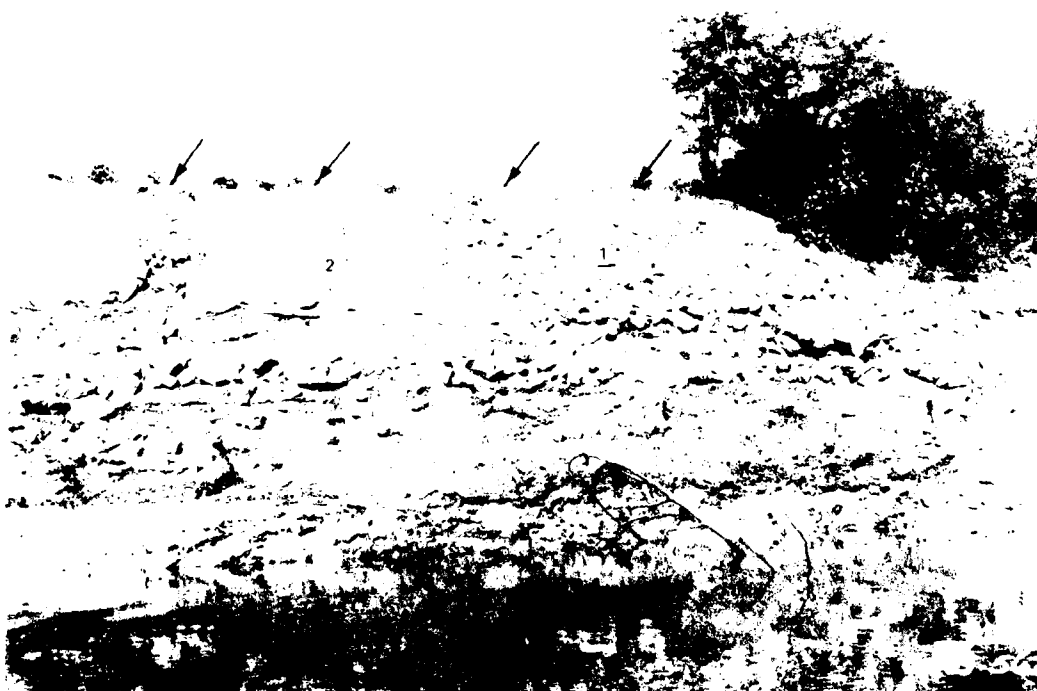
37. The water level rose only twice during the summer months to the point where about one third of the bank was covered with water. These changes in the water level were slow and caused little additional damage to the bank. Photo 79 shows the condition of the bank in July 1980 as volunteer vegetation and bushes (cottonwood and willow) began to grow in areas that can be seen at about half bank. Vegetation and bushes did not emerge on the lower part of the bank as the river covered this part of the bank several times during the growing season. Photos 80 through 83 illustrate closeup views of the vegetation and small bushes growing on the bank as well as the condition of Items 1 through 8. Areas of the bank that shifted and failed during sudden drops of the river caused the riprap to settle and move (Items 1 and 7) and ultimately tear membrane materials (Items 2-6 and 8). These conditions can also be observed in these photographs.

Photo 80. Close-up of Items 1 and 2, July 1980

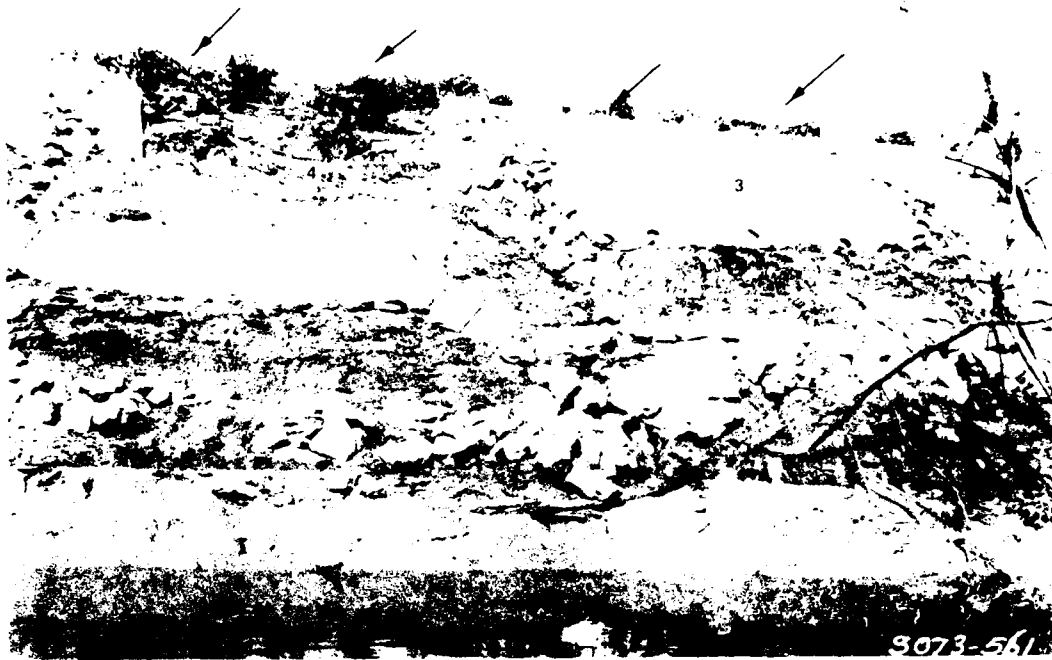
Photo 81. Close-up of Items 3 and 4, July 1980

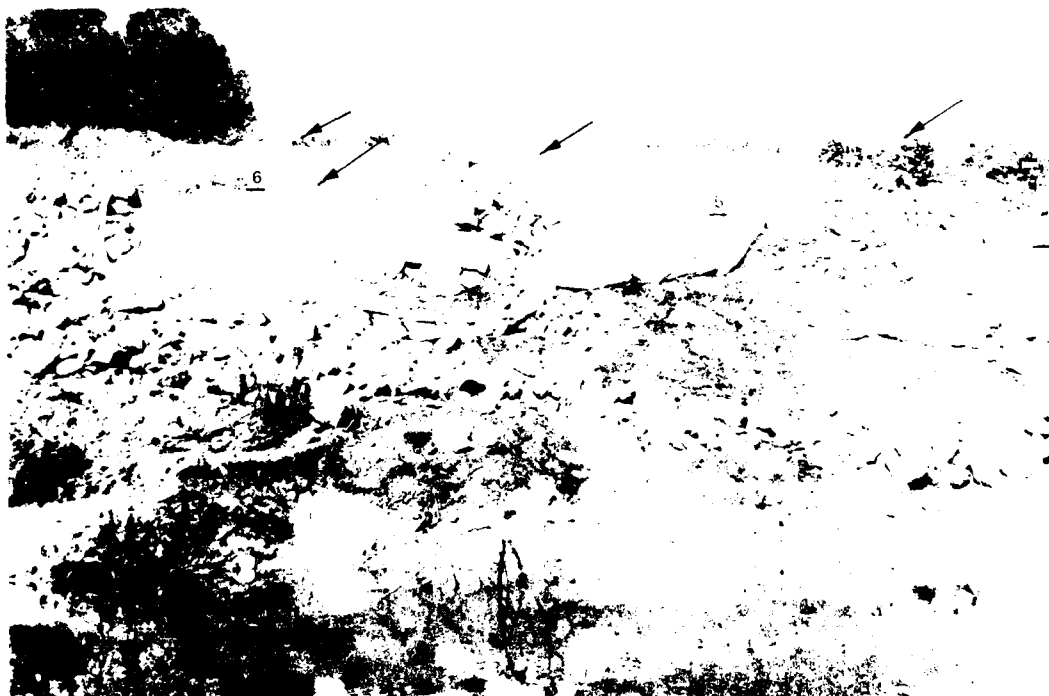
Photo 82. Close-up of Items 5 and 6, July 1980

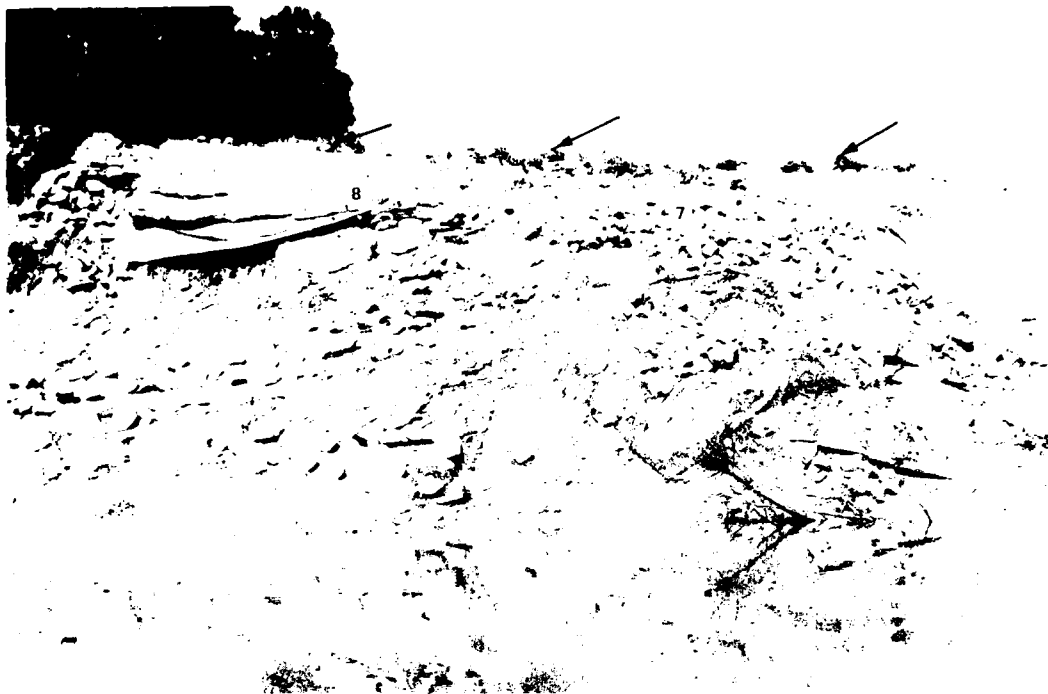
Photo 83. Close-up of Items 7 and 8, July 1980

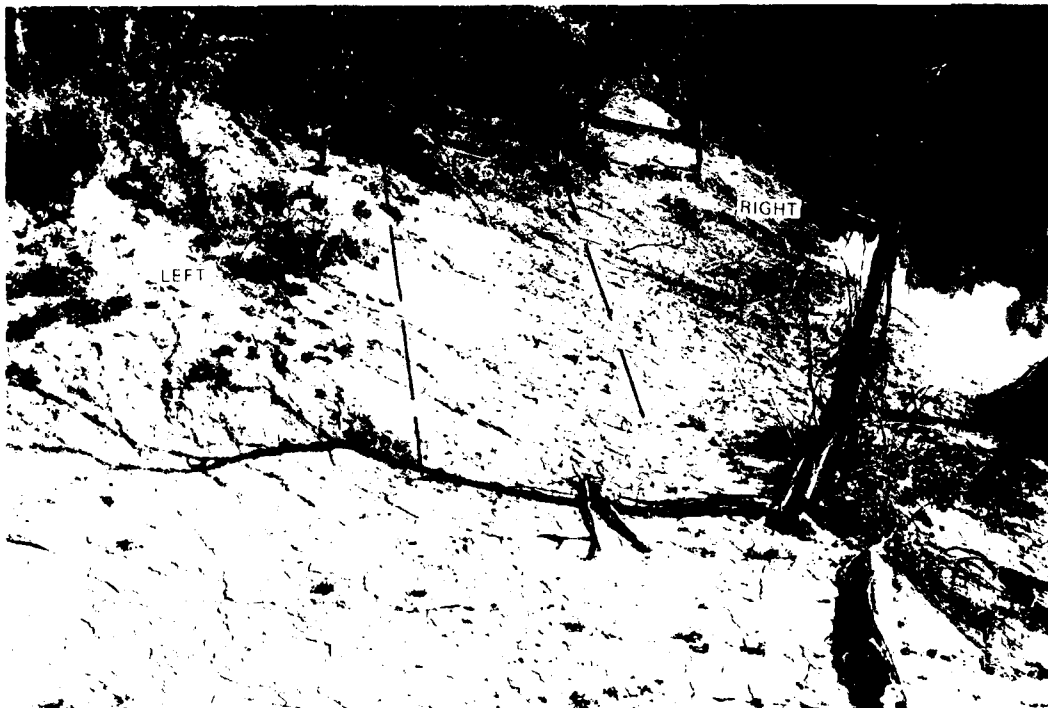
38. The shifting and sliding of bank areas (paragraphs 34-37) that occurred upstream and downstream in areas not associated with the test area also occurred throughout the river basin. Photos 84 through 86 are the views of the riverbank approximately 3 miles downstream from the test area where the bank failed as a result of long periods of high water

followed by rapid drawdowns of the water level. This condition occurred during the same period that the bank at the test site failed and caused damage to test items. Dashed lines have been drawn on Photos 84 and 85 to illustrate the location of the tree line before bank failure occurred. The trees and bank area shown to the left of the lines drawn on Photo 84 are shown after bank failure and displacement in Photos 85 and 86. Some of the trees remained on the lower slope of the bank, whereas others slid into the river. When this drawdown condition on the river occurred, soil was eroded from around a bridge pier immediately downstream and adjacent to the area described above. Photo 87 shows the condition of the bridge pier located on Mississippi Highway 27.

Photo 84. View of riverbank downstream of test area where sliding and slumping occurred as a result of the sudden drops in the water level of the river

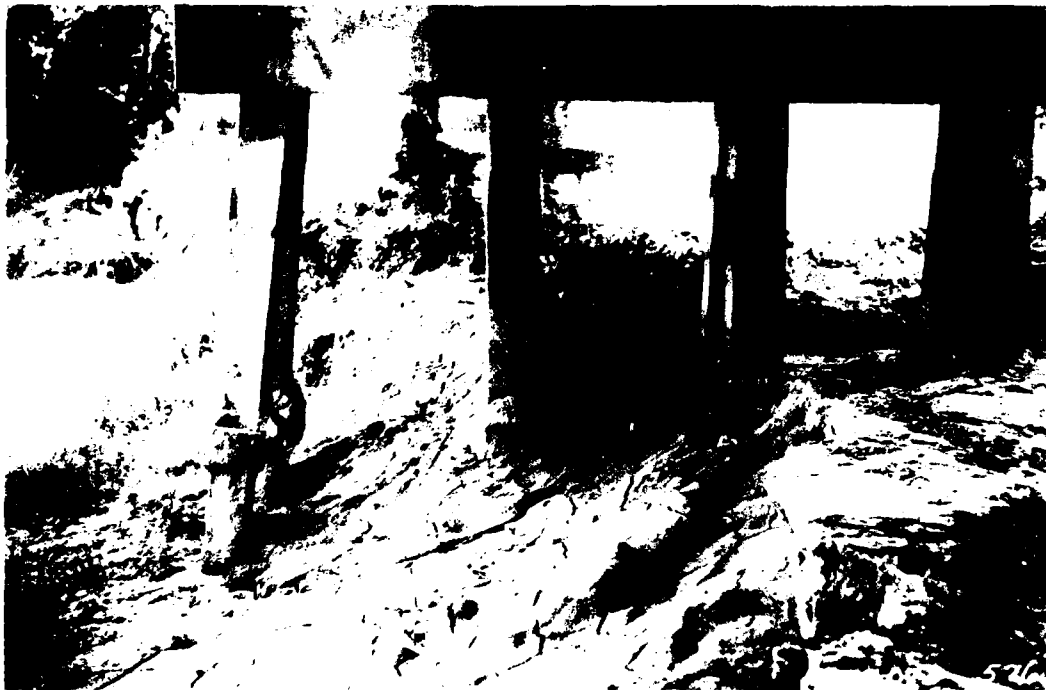
Photo 87. View of bridge pier downstream of area where sliding and sluffing of the bank and trees occurred during sudden drops in the water level of the river

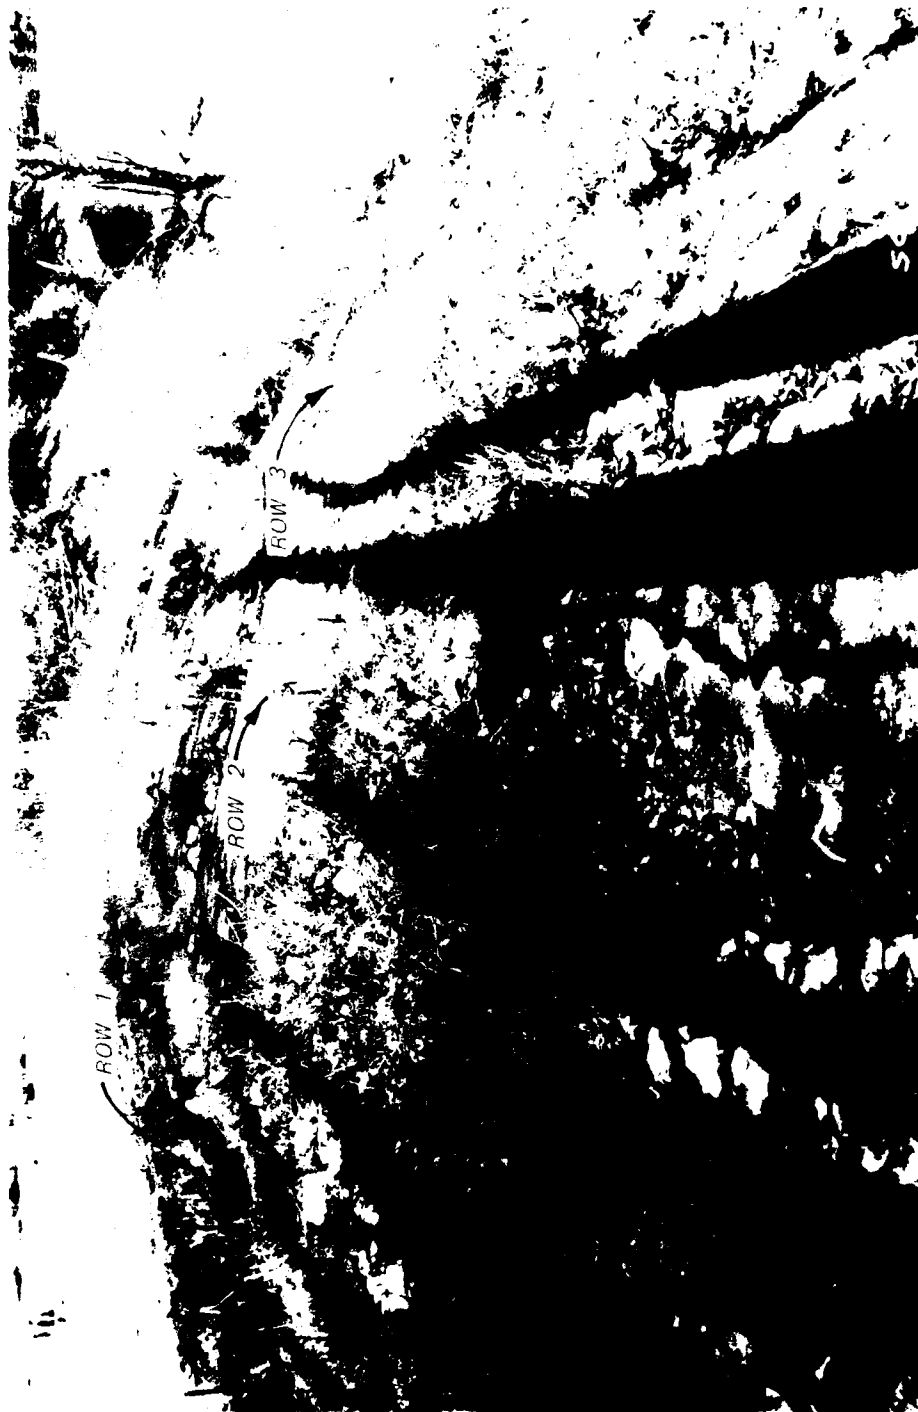
Incl 2

View (looking upriver) of 100' row after the splits were planted, 20 Jan 1981

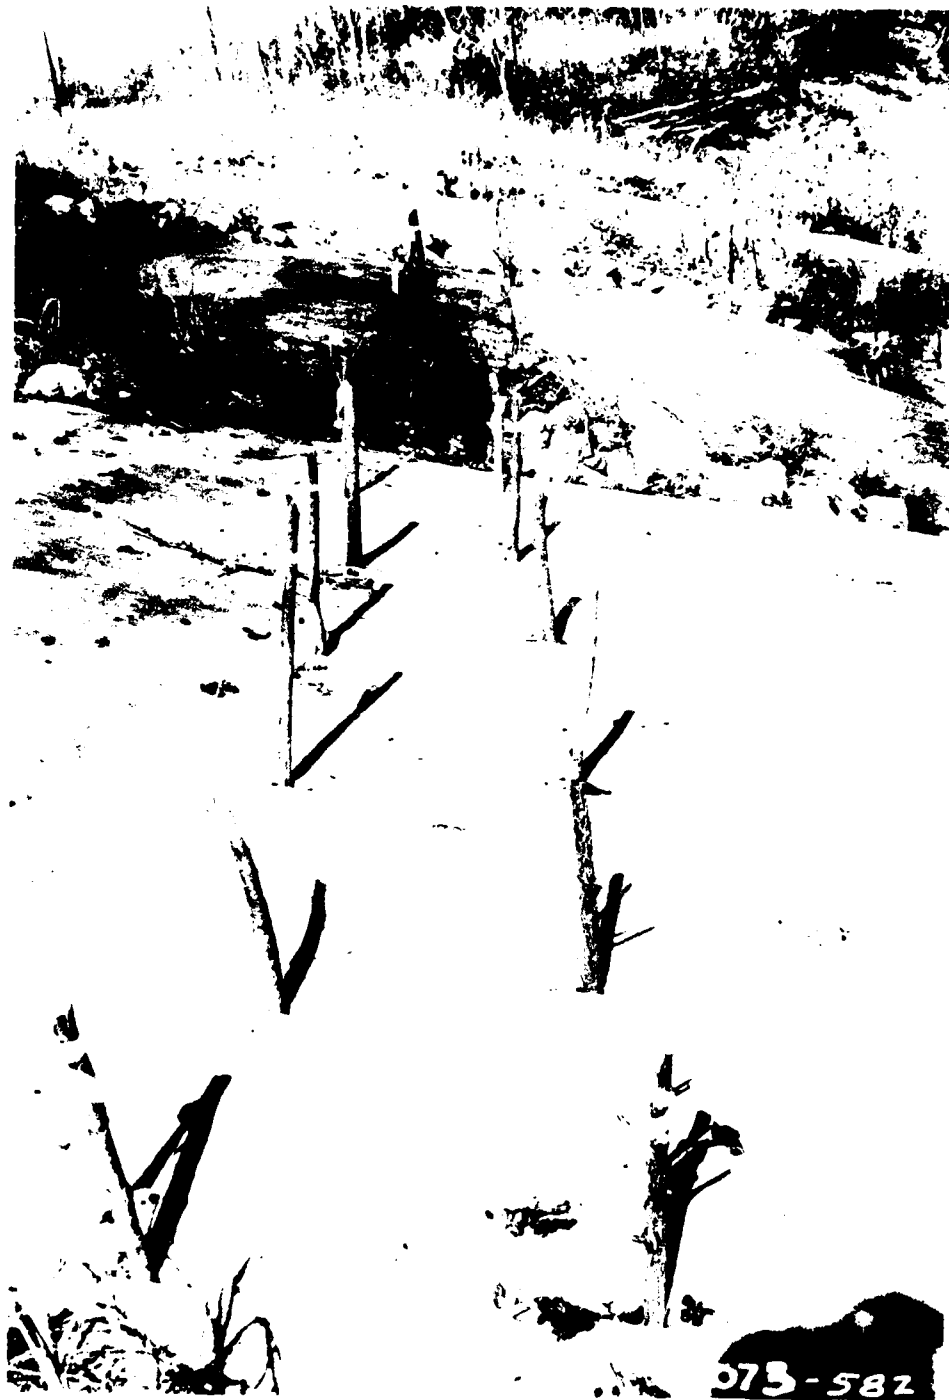
Incl 3

Close-up of sprigs on Item 5, 29 Jan 1981

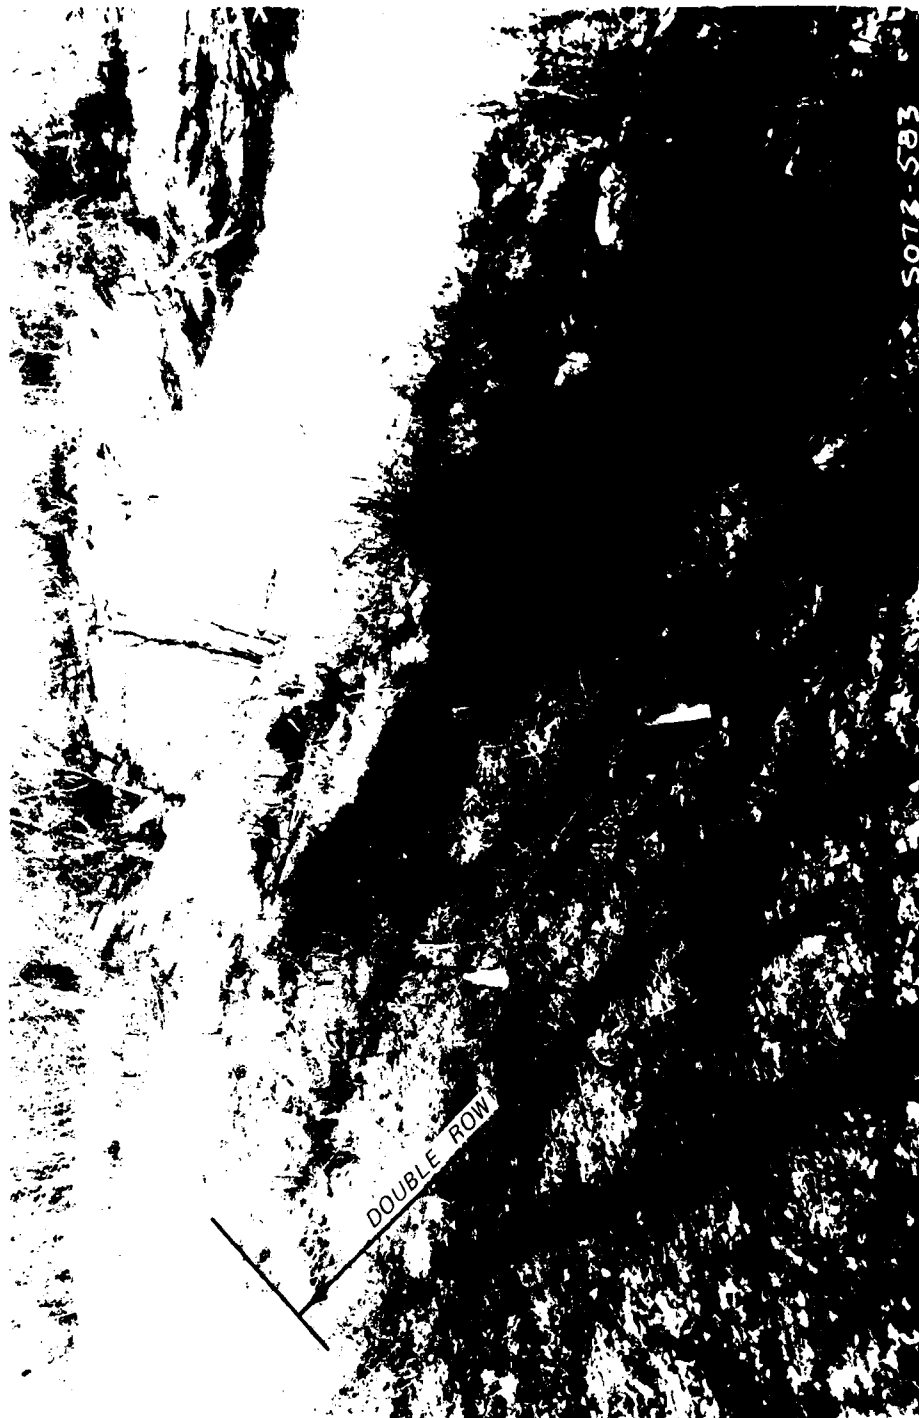
Incl 4

View (looking upriver) from top bank of test area after the sprigs were planted, 29 Jan 1981
